Final Remedial Investigation

Pownal Tannery Superfund Site Pownal, Vermont

July 2002

Metcalf & Eddy, Inc. 30 Harvard Mill Square Wakefield, Massachusetts 01880

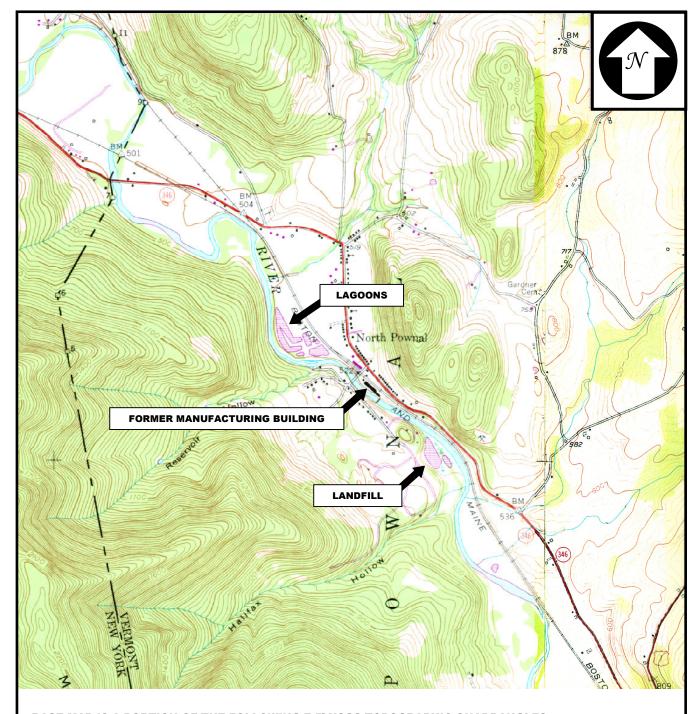
Figure 1.2-1 SITE LOCATION MAP

BASE MAP IS A PORTION OF THE FOLLOWING 7.5' USGS TOPOGRAPHIC QUADRANGLES: POWNAL, VT, 1954; NORTH POWNAL, VT-NY, 1954, PHOTOREVISED 1980
